CULTURAL LANDSCAPE REPORT FOR VANDERBILT MANSION NATIONAL HISTORIC SITE

VOLUME II: TREATMENT

HYDE PARK, NEW YORK

By John W. Hammond, Historical Landscape Architect

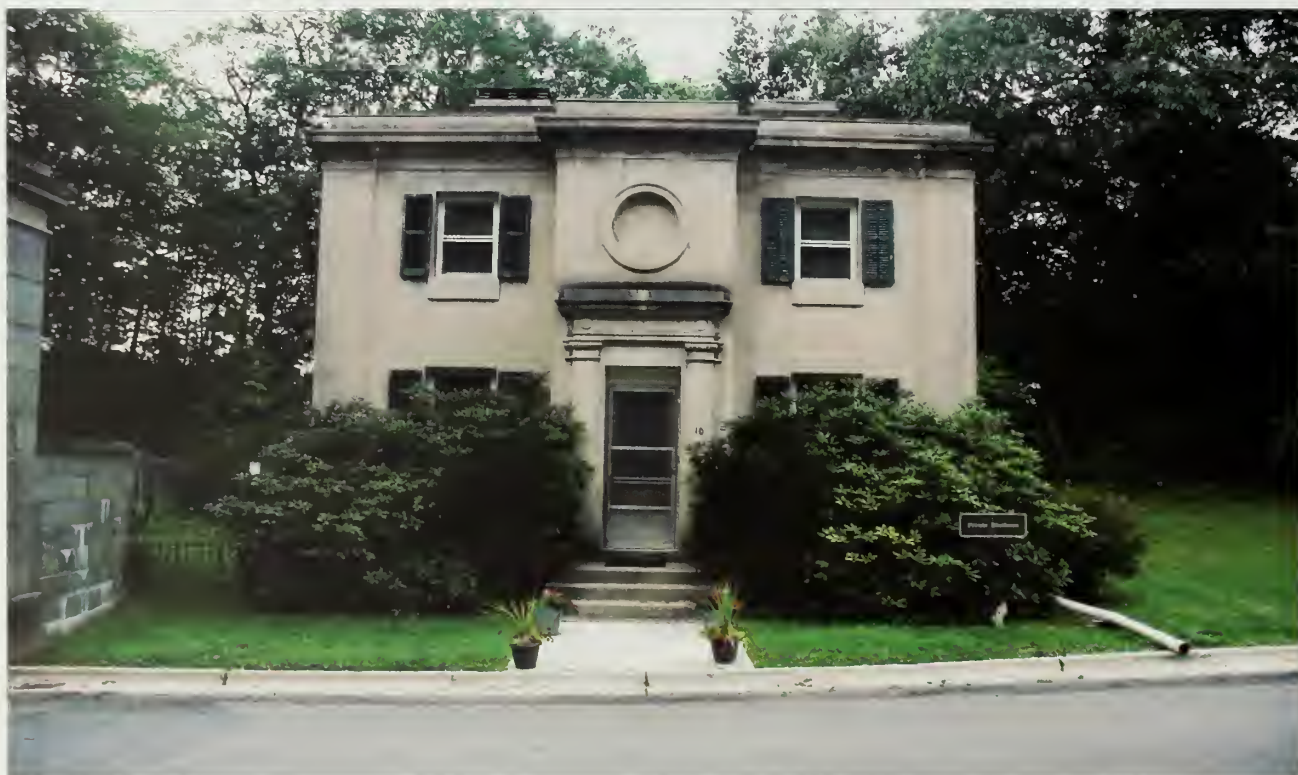
Figure 60. South Gatehouse looking west, showing overgrown foundation plantings (OCLP 2008).

59.	South Gatehouse looking southwest, showing low foundation plantings, 1956.	142
60.	South Gatehouse looking west, showing overgrown and incompatible foundation plantings, 2008.	142

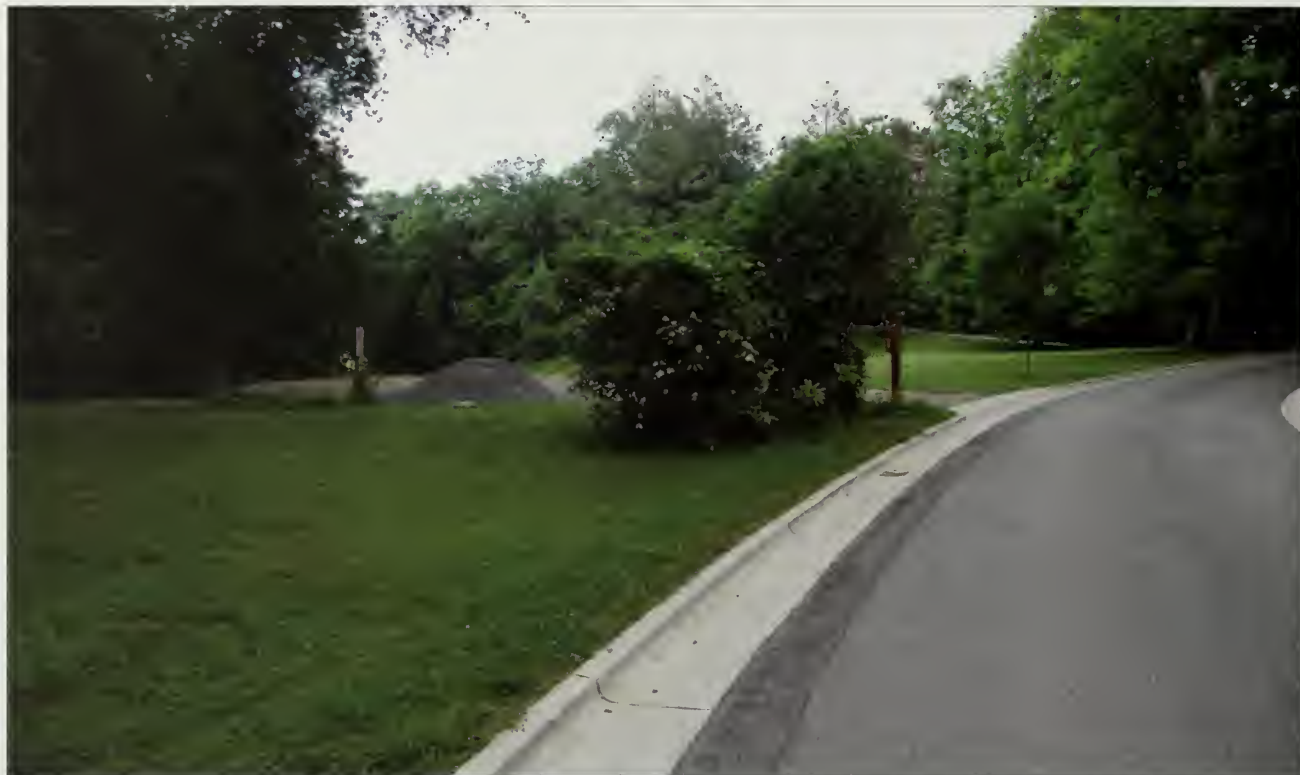
Figure 62. View of South Drive looking north, showing rhododendron covered in vines (OCLP 2008).

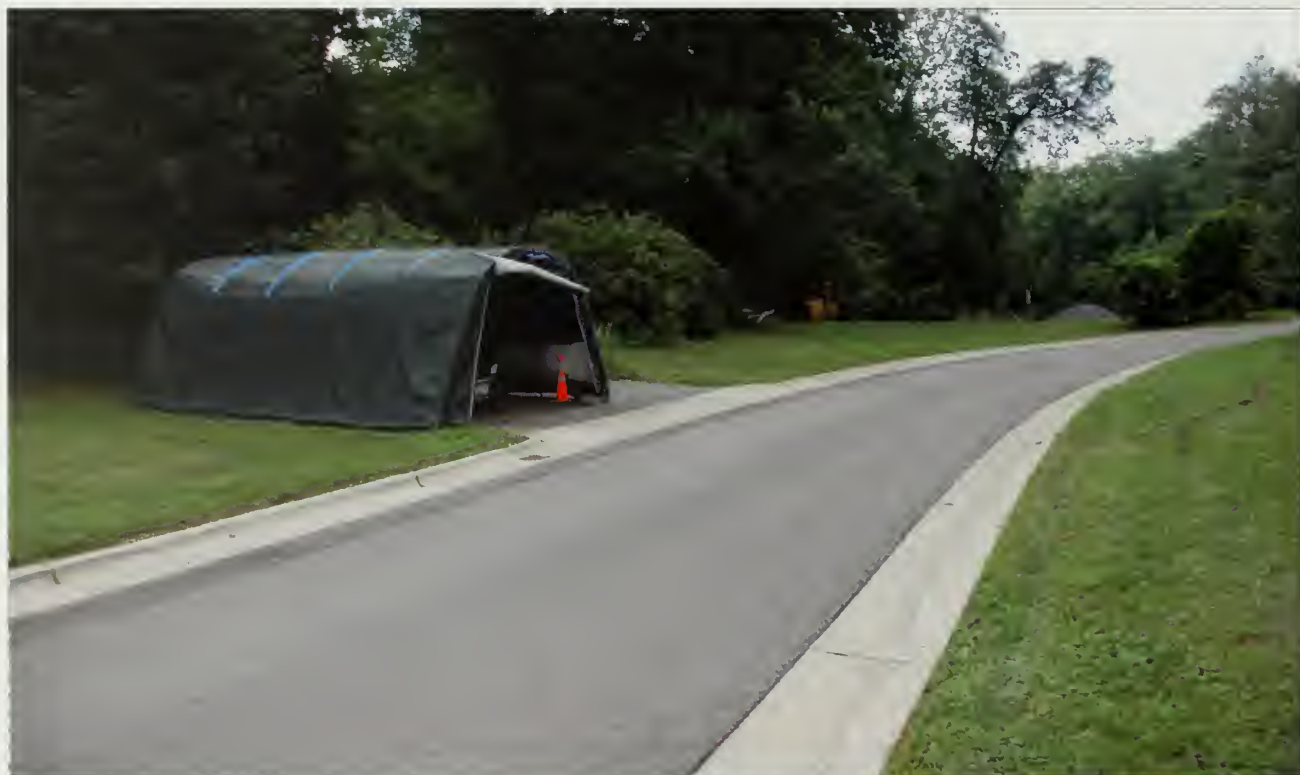
Figure 63. View of South Drive looking north, showing incompatible temporary parking shelter (OCLP 2008).

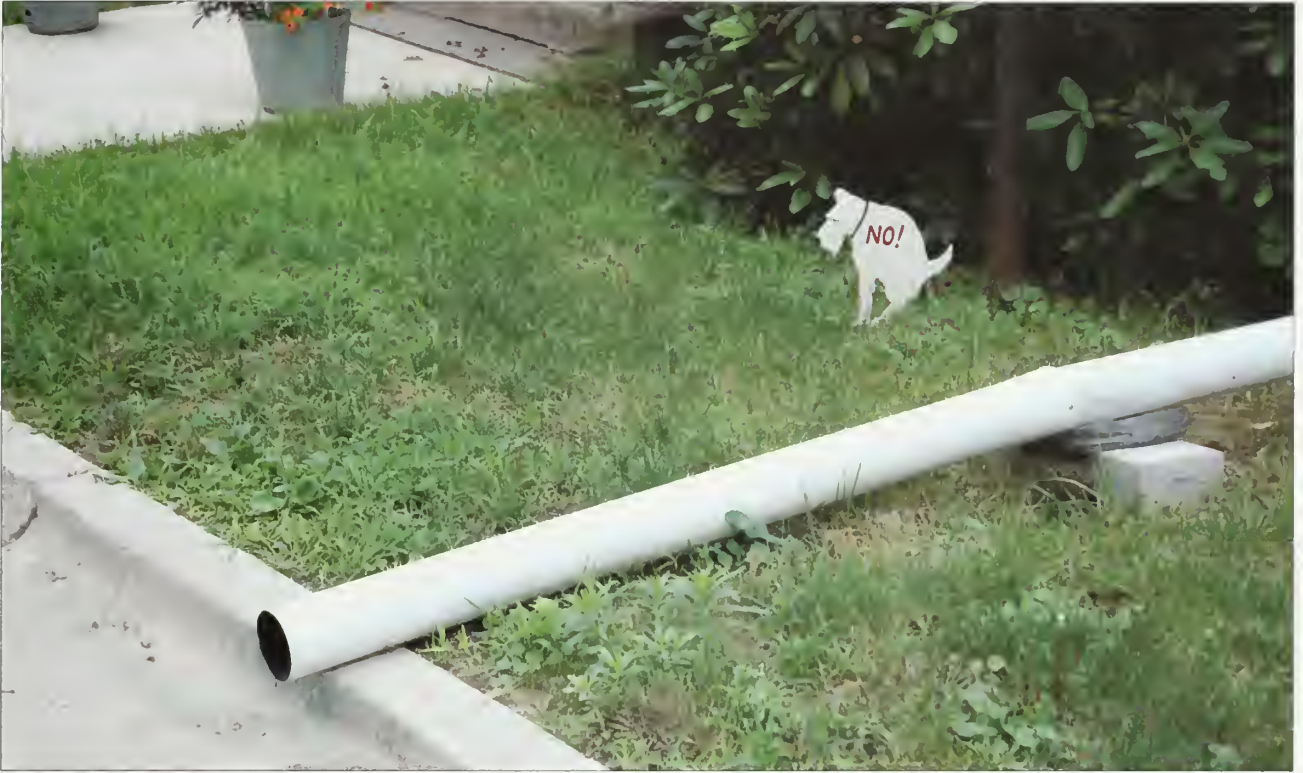
Figure 64. Downspout drain pipe and lawn ornaments at the South Gatehouse (OCLP 2008).

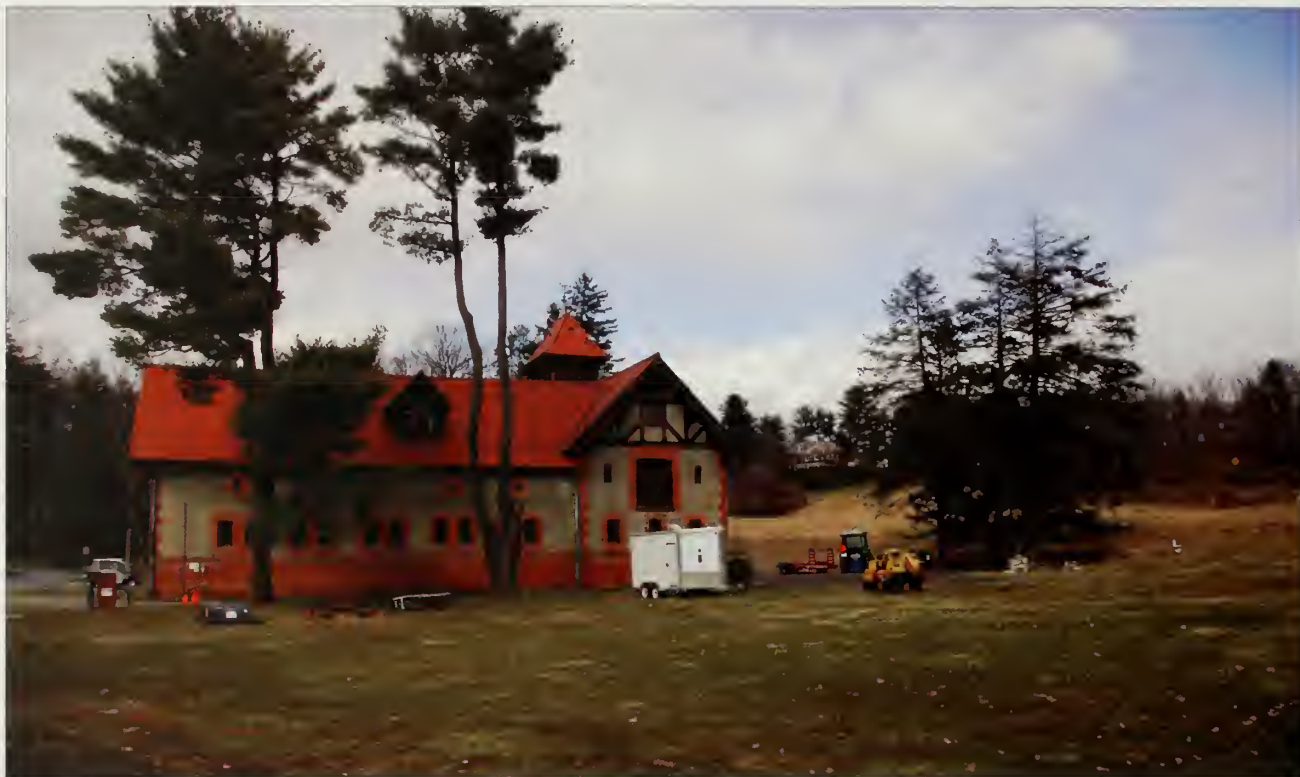
Figure 66. View of the Coach House south elevation looking north, showing the two historic white pine trees that are in decline. The third replanted tree is visible behind the white trailer (OCLP 2008).

Three white pine trees historically grew along the south façade of the Coach House. One of these trees has recently been replaced, and the other two are of an advanced age and in declining health (Figure 66). Remove and replace the two remaining trees in kind. The replacement trees should match the one already replaced in age and variety so that the three trees grow similarly.

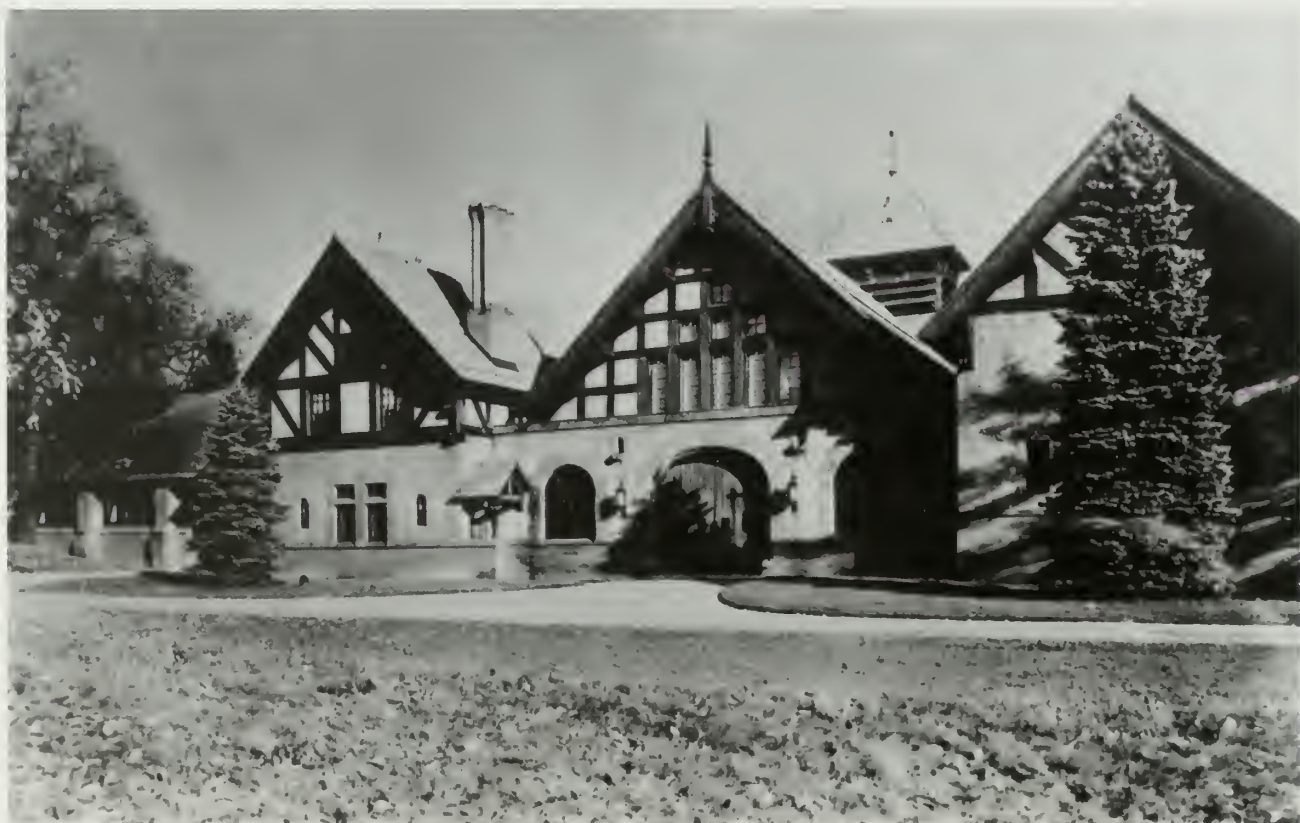
Figure 67. View of the Coach House west elevation with two large spruce trees in front, date unknown. The species of the spruce is unknown, however, the trees exhibit the branching habit and density of Colorado blue spruce (VAMA V-3120).

Photographs and aerial photographs from the historic period indicate that two large spruce trees were planted on the west façade of the Coach House (Figure 67). While the species of the trees is unknown, the trees exhibit the branching habit and density of Colorado blue spruce. To reinstate these spruce trees, plant one Colorado blue spruce (*Picea pungens*) in the planting bed in front of each of the Coach House wings.

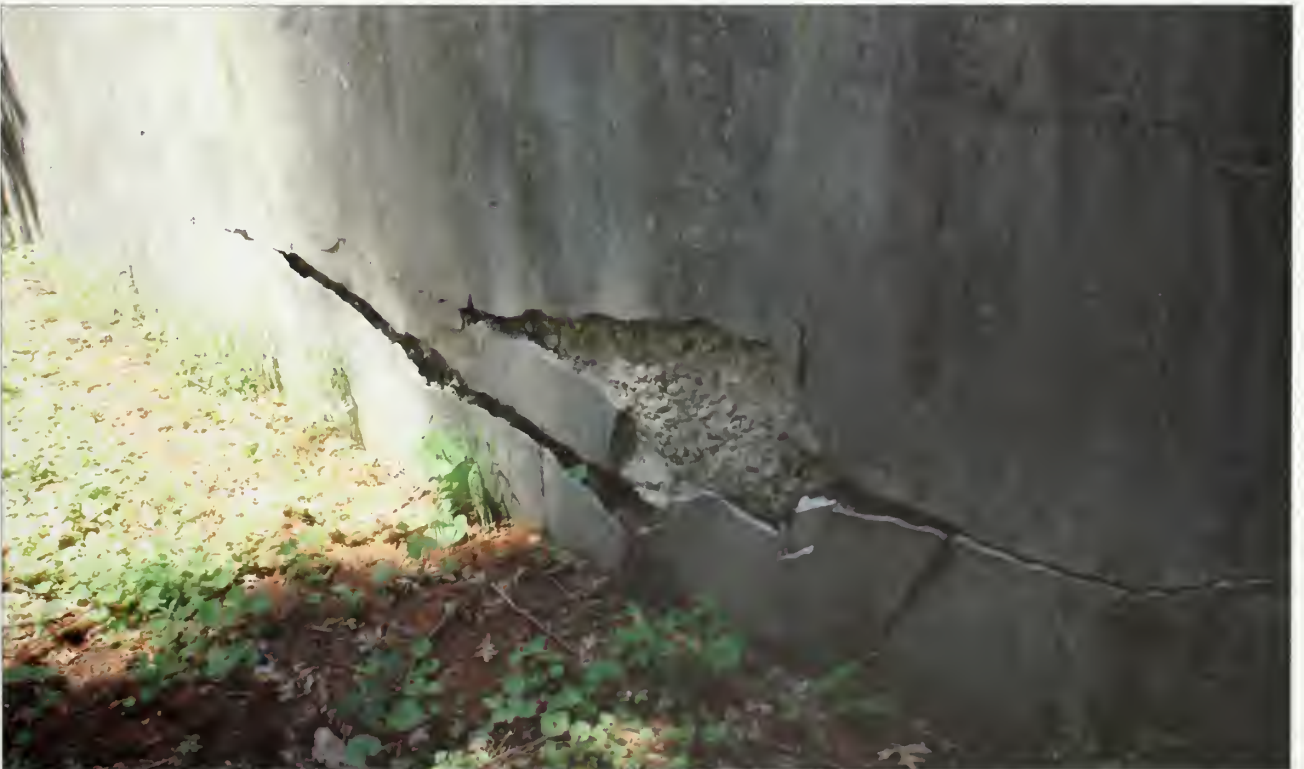
Figure 69. View of one of the subway walls, showing cracking and spalling (OCLP 2008).

69.	View of one of the subway walls, showing cracking and spalling, 2008.	147
70.	View of the conifer screen looking east, showing the three-tiered planting, 1941.	148

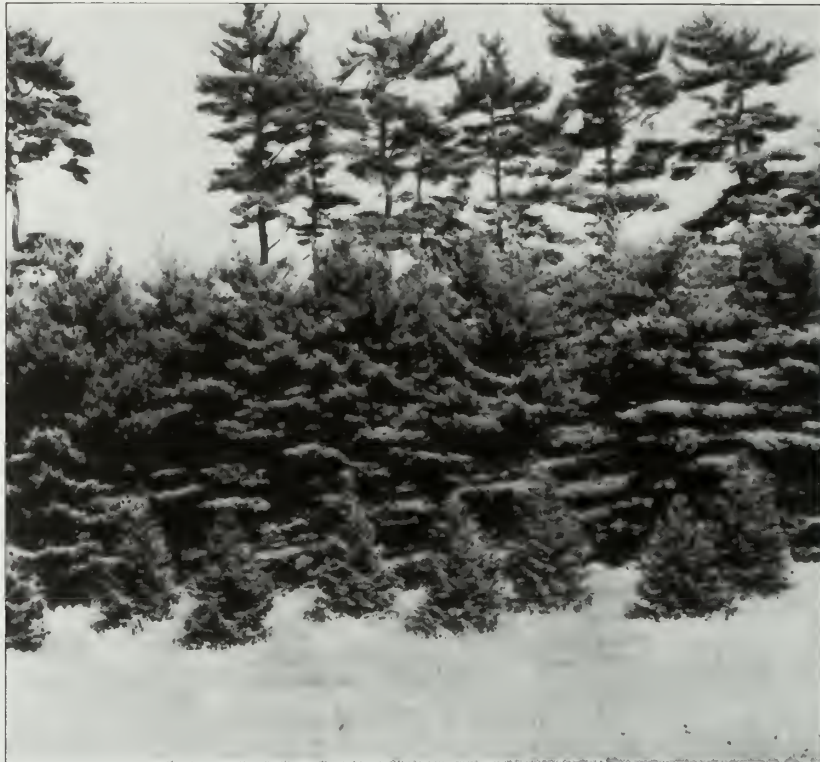
Figure 70. View of the conifer screen looking east, showing the three-tiered planting, 1941. The photo shows a row of mature white pines with a row of younger white pines in front of them. In front of those two rows is a newly-planted row of Canadian hemlocks (VAMA V-742).

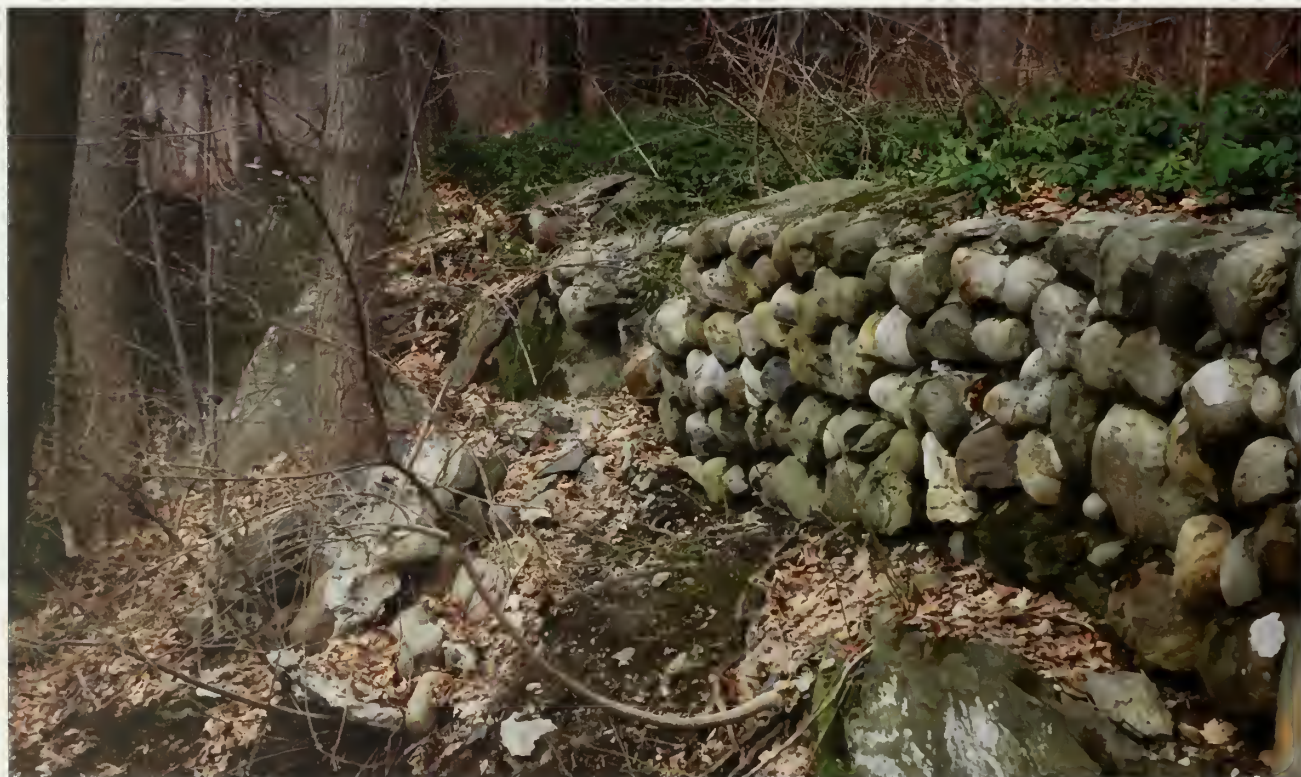
Figure 72. View of the path along Crum Elbow Creek looking south from the White Bridge. While there is no historical documentation of this path, its location, construction, and the materials used suggest that it dates to the historic period. The path is currently in poor condition in places and is underutilized (OCLP 2008).

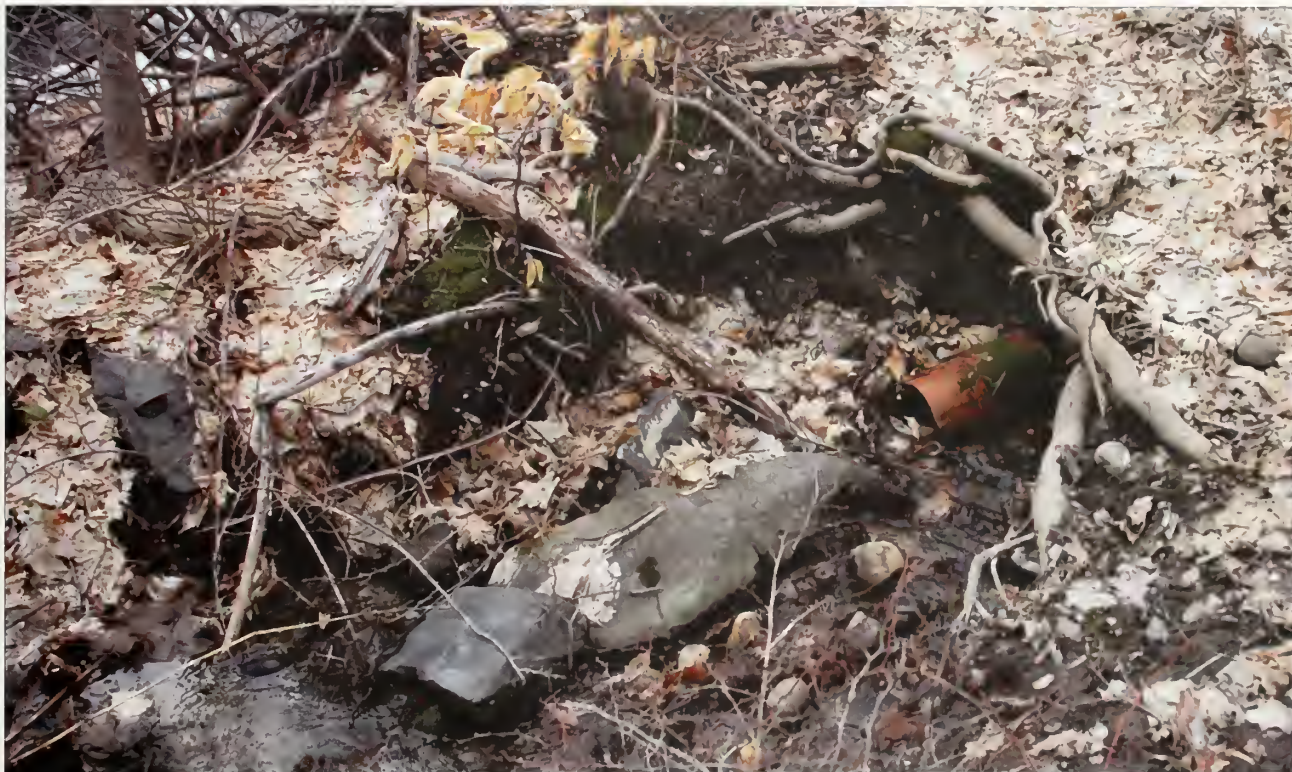
Figure 74. Broken clay drain pipe near the Power House (OCLP 2008).

73.	View of Crum Elbow Creek looking north, showing the remnants of the stone causeway path, 2008.	150
74.	Broken clay drain pipe near the Power House, 2008.	151

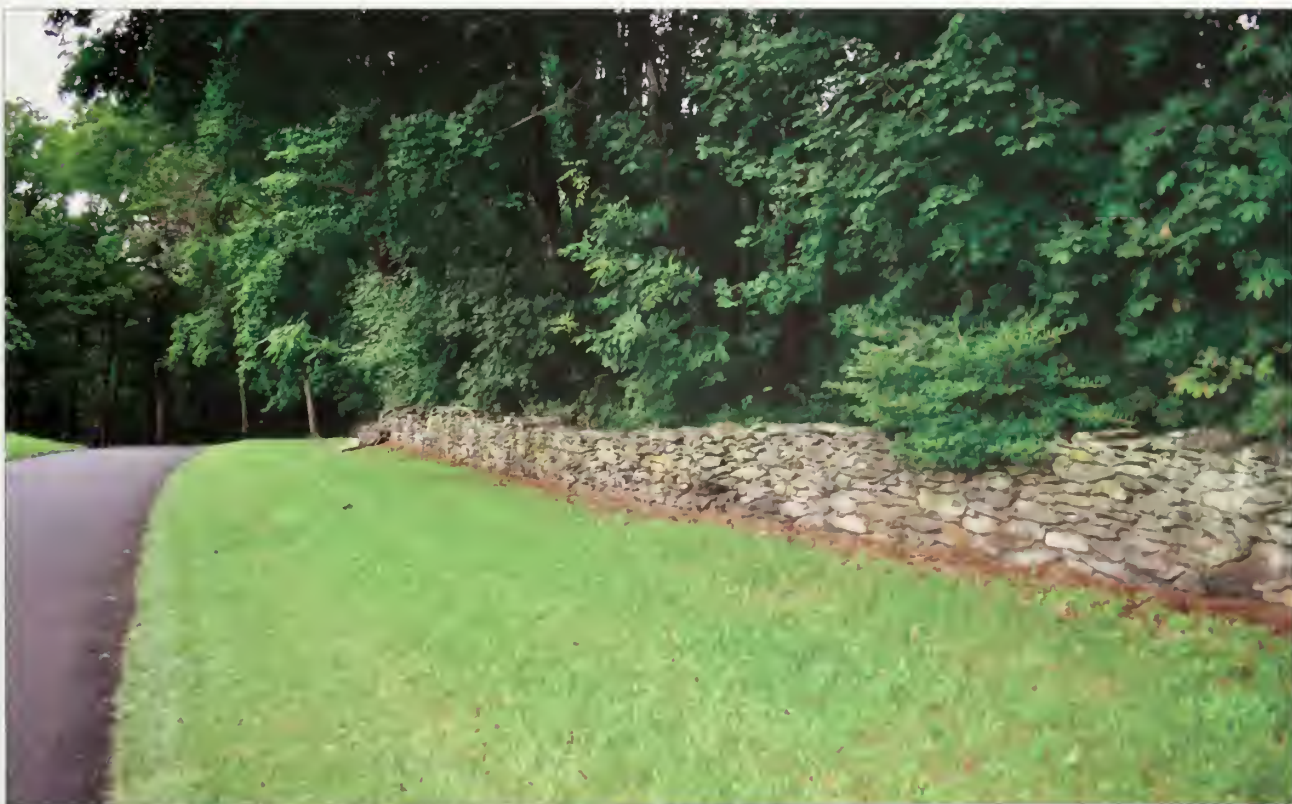
Figure 75. View looking west of the dry laid field stone wall along the north side of Bard Lane (OCLP 2009).

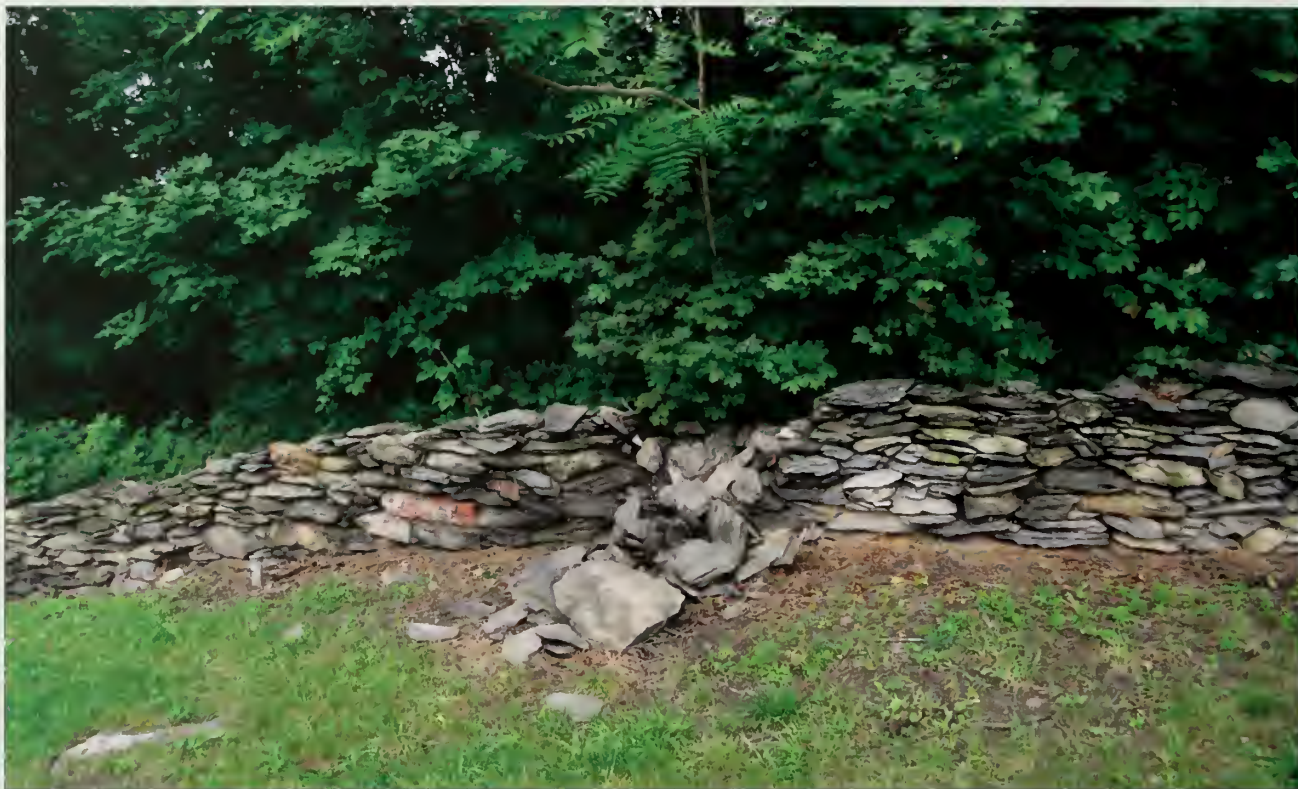
Figure 76. View looking north of a collapsed section of the dry laid fieldstone wall north of Bard Lane. The collapsed sections are routinely restacked by park maintenance staff (OCLP 2009).

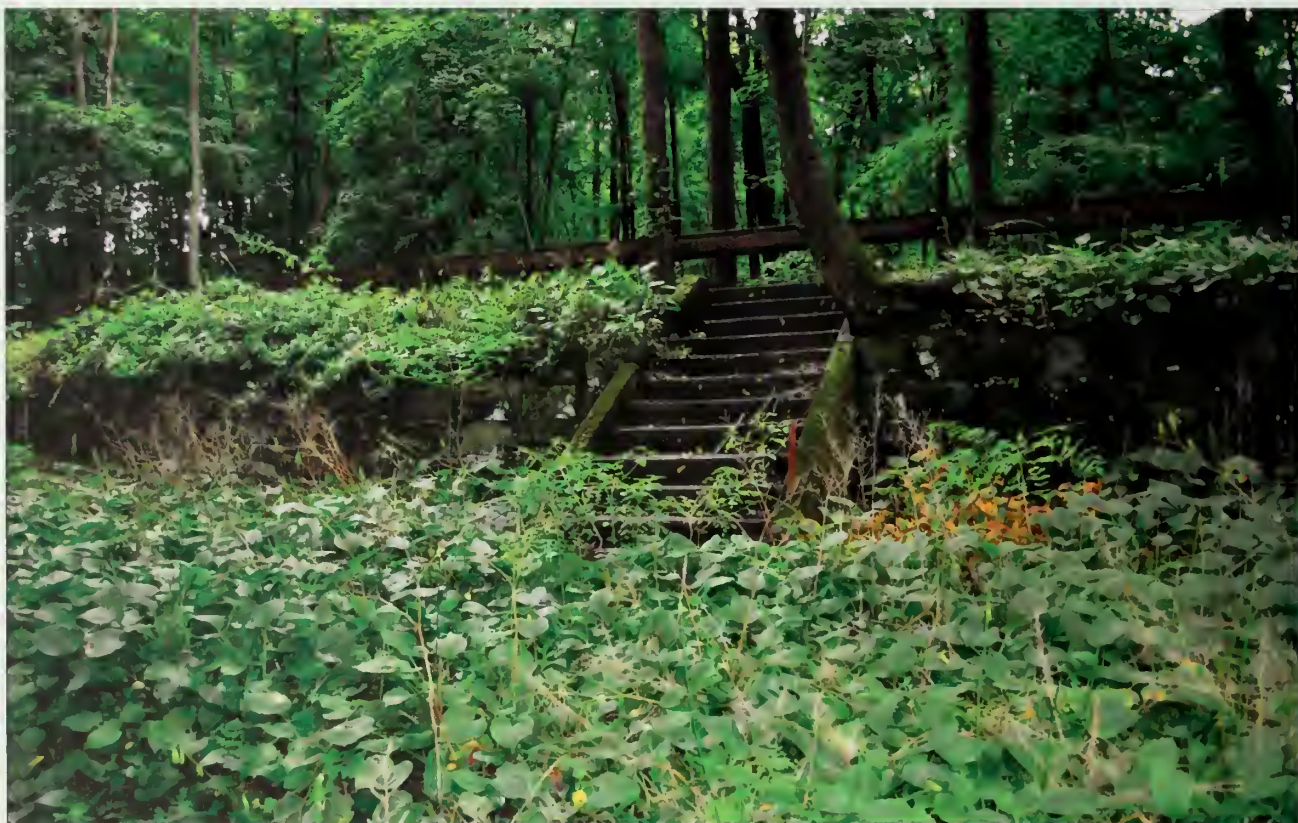
Figure 77. View looking south from the Gardener's cottage site to the steps and retaining wall along the north side of Bard Lane near the railroad bridge. Hosta carpets the understory (OCLP 2009).

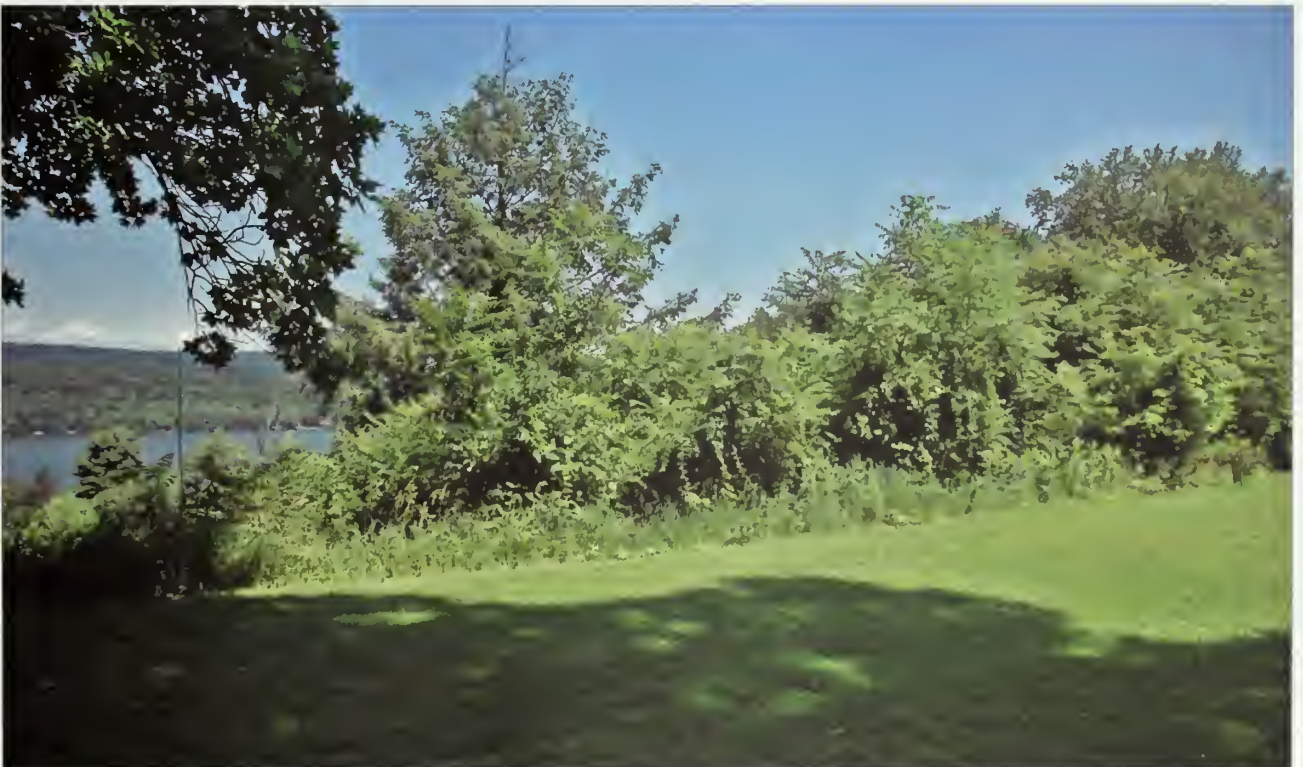
Figure 79. View looking northwest from the Mansion, showing ailanthus and other brush obscuring the view (OCLP 2008).

Some of the most important views at Vanderbilt Mansion National Historic Site are from the areas around the Mansion and Pavilion toward the river and mountains to the west. During the historic period, these views were open and sweeping, with a limited number of specimen trees directly on the edge of the terrace to frame the views. The slopes below the Mansion and Pavilion were free of obscuring trees and brush. Today, the difficulty in keeping these steep slopes mowed has led to recurring colonization by trees and shrubs, especially dense thickets of tree-of-heaven (*Ailanthus altissima*). Periodic efforts to remove the tree-of-heaven, including one completed recently, are effective in the short term in opening up the views, but the plants eventually return to once again obscure the views (Figure 79).

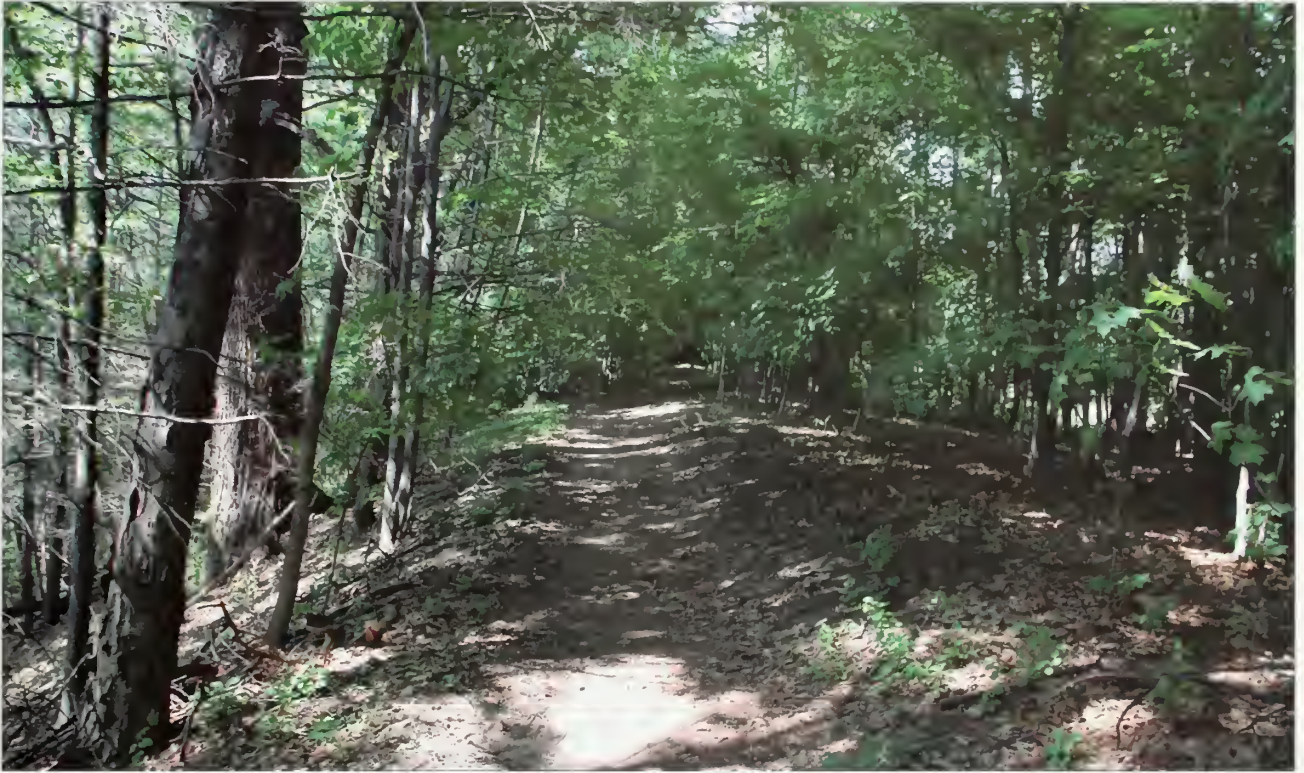
Figure 81. View of the footpath along the ridge south of the formal gardens looking north, showing the current dense forest character (OCLP 2008).

The slope below the formal gardens was open meadow during the historic period, providing a significantly different character than the densely forested slope today. The path that climbs the ridge from Crum Elbow Creek in the south to the formal gardens would have offered views of the river to the west through a line of specimen trees that grew along the top of the slope (Figure 80). Since the historic period, the slope was not mowed and the forest grew up, blocking the views and casting the path into deep shade. Today, the forest is composed mostly of Norway maples with scattered large tulip trees and other species (Figures 81 and 82).

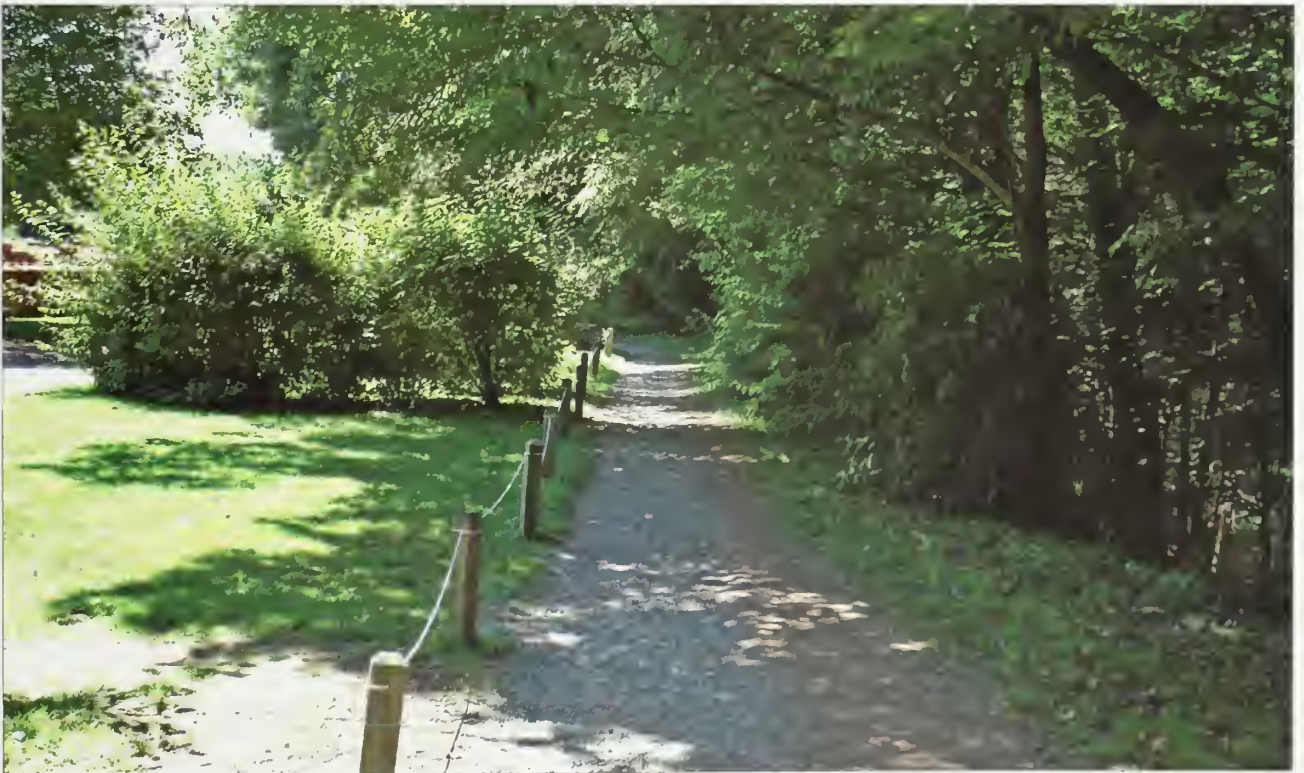
Figure 82. View of the footpath between the Mansion and the formal gardens looking south. Historically clear or filtered views to the west (right of the photo) are currently obscured by dense forest (OCLP 2008).

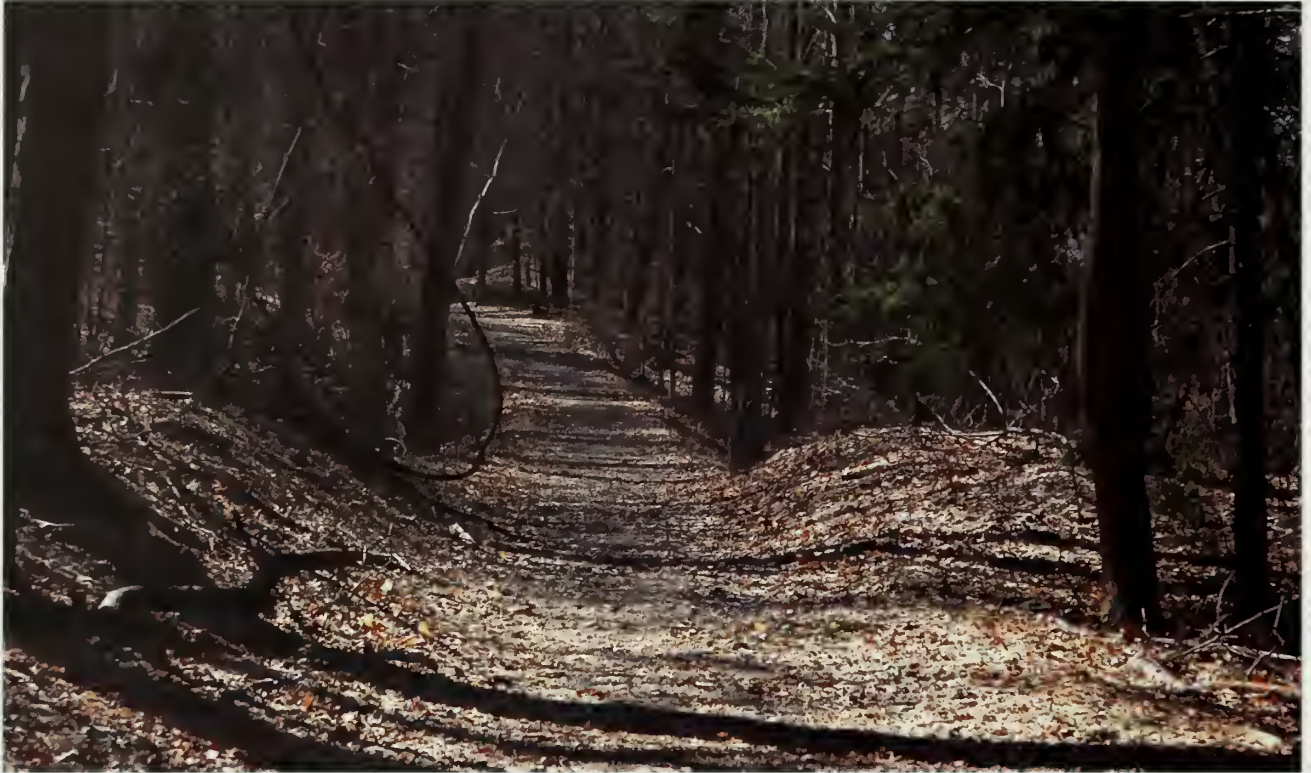
Figure 83. View of the Lower Woodland Drive looking south, showing the deep wooded character of the drive (OCLP 2008).

The unpaved drive in the lower woodland along the river was used for access to Bard Rock and as a pleasure drive during the Vanderbilt period. The southern portion of this drive was constructed in around 1898, and the northern portion about eight years later when Vanderbilt acquired the Sexton Tract. Today it is closed to vehicular traffic, but is used as a pedestrian route (Figure 83). Retain this feature as a pedestrian route between the South Gate and Bard Rock. Maintain the drive at its current width of sixteen feet with a gravel surface, making repairs when necessary.

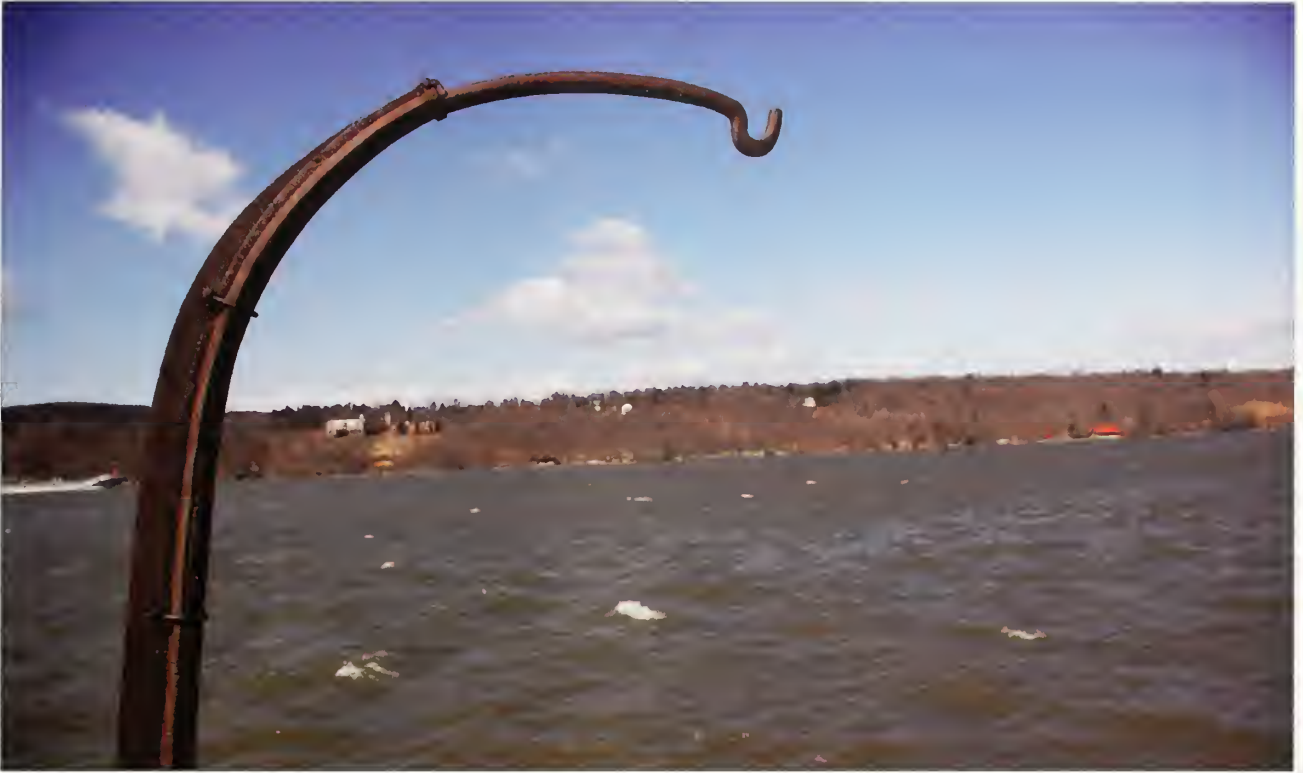
Figure 85. The iron boat hook at Bard Rock is currently unprotected from the elements and is covered in a layer of rust (OCLP 2008).

85.	The iron boat hook at Bard Rock, showing rust, 2008.	157
86.	The iron eyelet affixed to Bard Rock, showing rust, 2008.	157

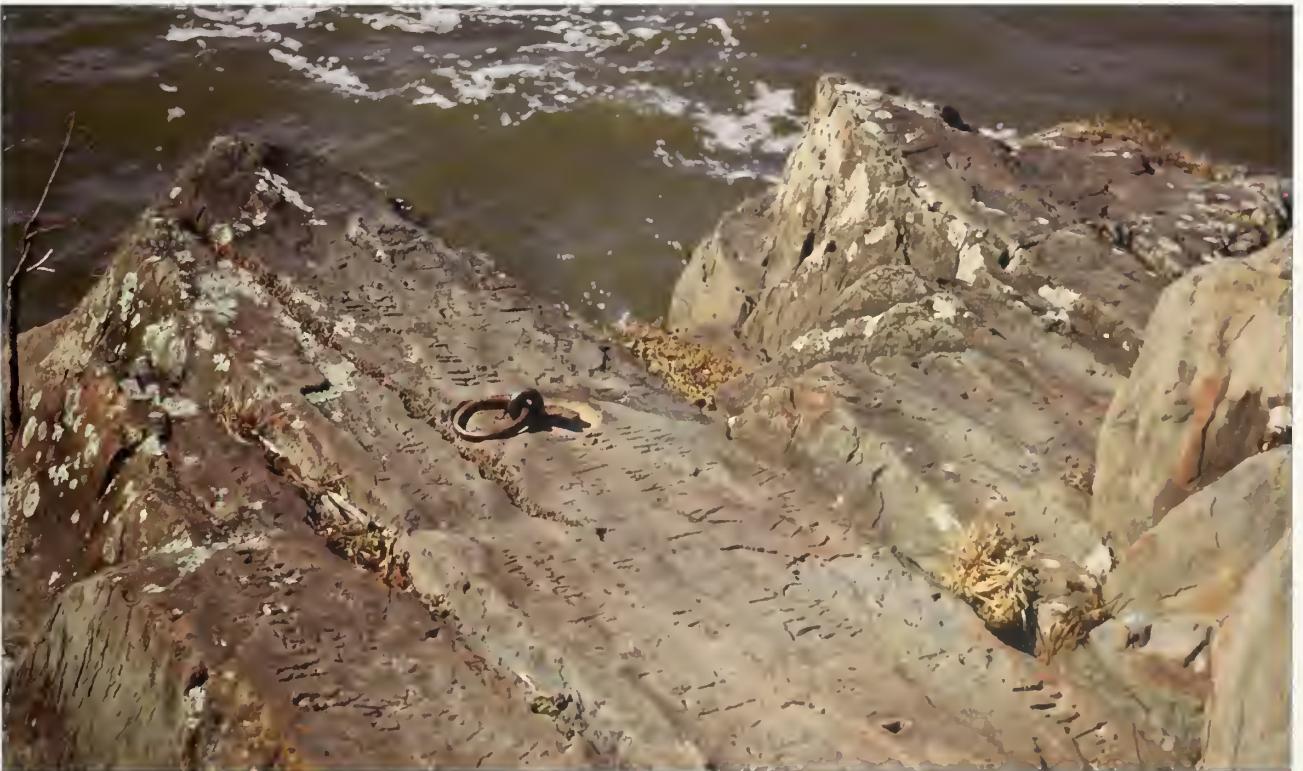
Figure 86. The iron eyelet affixed to Bard Rock is also being impacted by rust (OCLP 2008).
